**SITE ASSESSMENT REPORT
FOR
JEFFERSON PROCESSING SITE
MINGO JUNCTION, JEFFERSON COUNTY, OHIO
TDD: S05-9903-008
PAN: 9M0801SIXX
DOCUMENT CONTROL NUMBER: START-05-23-050105**

January 31, 2000

**UNITED STATES ENVIRONMENTAL PROTECTION AGENCY
Emergency Response Branch
77 West Jackson Boulevard
Chicago, Illinois 60604**

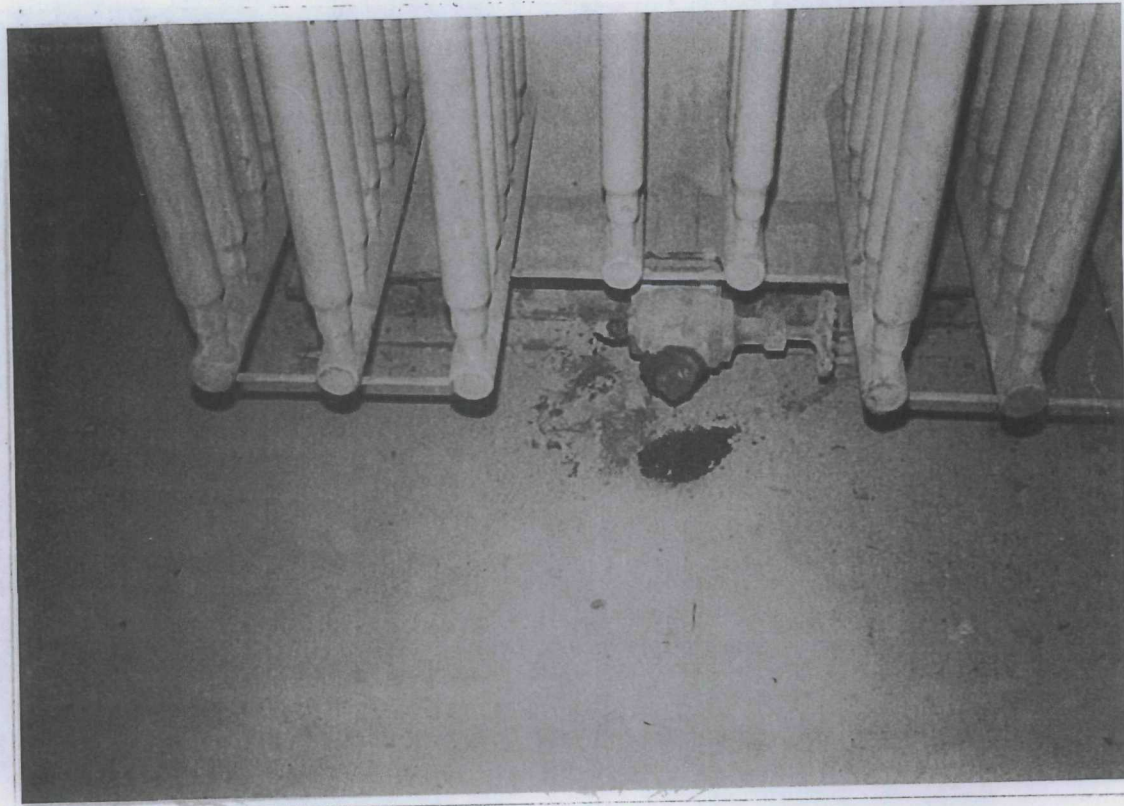
Room 1 on the first floor of Plant J-1 contained transformers C-505415 and C-503736. A 4-inch by 5-inch drip spot was observed under a valve near the bottom of the General Electric Pyranol

Transformer, serial number C-505415. According to site security personnel, the spot was from a previous sample event when the valve was opened to collect the sample. The valve currently appeared to be closed and did not appear to be leaking. Rust and corrosion was observed on parts of the General Electric Pyranol Unit Substation Transformer, serial number C-503736, particularly on the cooling pipes. A bottom pipe also appeared to be leaking onto the floor. Room 2 on the first floor of Plant J-1 contained transformer C-856081 which was observed to have badly corroded pipes. It was also observed that the room itself was damp. Room 3 on the third floor of Plant J-1 contained one known transformer. Access into the room is not possible due to large metal bars which had been welded into the door frame. A blue label was observed on the doorway which stated that the dielectric fluid in the unit was tested and subsequently defined as containing less than 50 parts per million (ppm) PCBs and was therefore classified as non-PCB. Room 4 on the third floor of Plant J-1 was also not accessible and placarded with a blue label identical to the one on the doorway into Room 3 of Plant J-1. Room 5 on the third floor of Plant J-1 contained the General Electric Pyranol Unit Substation Transformer, serial number C-503735. A floor drain was located within 5 feet of the transformer. There are two access doors into Room 5. Room 6 on the third floor of Plant J-1 contained the General Electric Transformer, serial number C-657628. This transformer was observed to have a label on its identification (ID) plate indicating that the transformer had been sampled on 3/12/86 and was found to contain 136 ppm PCB by Ohio Transformer Corporation, Louisville, Ohio. A moisture and or oil ring was observed around the bottom of the transformer and around a sealed access plate at the top of one of the sides.

DESCRIPTION: A spot of oil residue was observed below a plugged opening on transformer C-505415. The plug does not appear to be leaking currently.

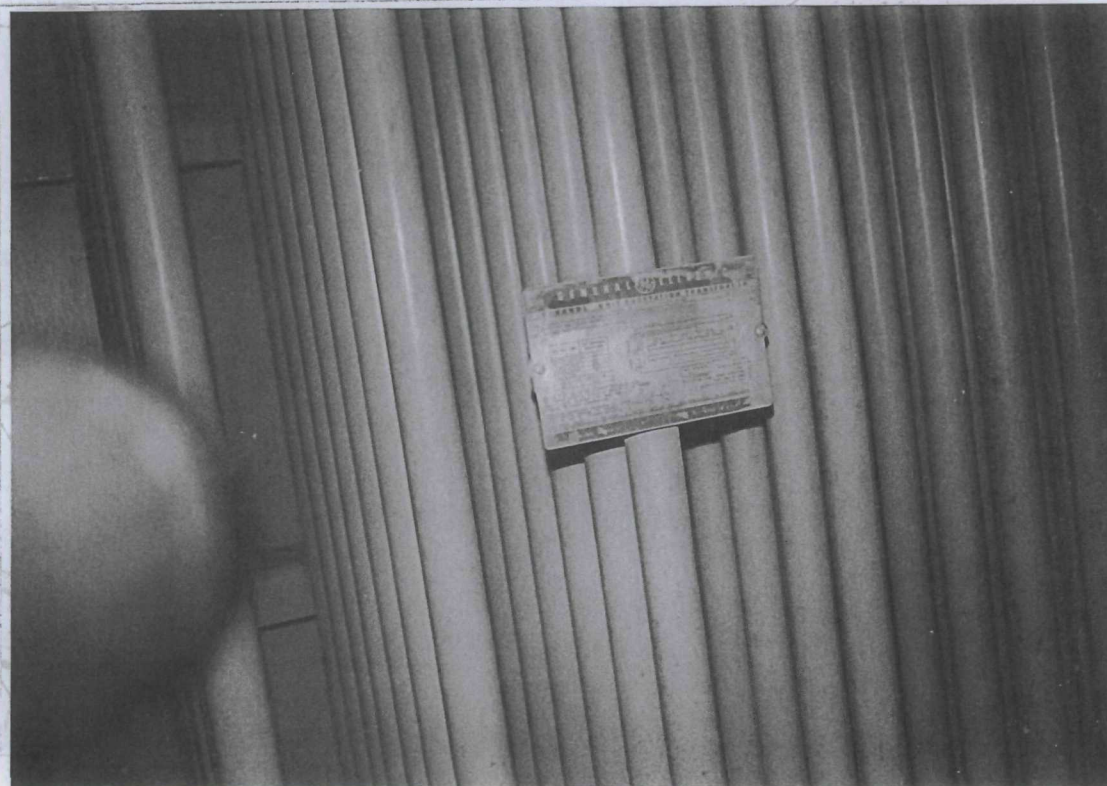
DESCRIPTION: Transformer C-503736 was labeled with a metal plate identifying it as a General Electric Pyranol Unit Substation Transformer. This transformer was located in Room 1, Plant J-1. Rust development on the cooling pipes was observed by START and IIS EPA

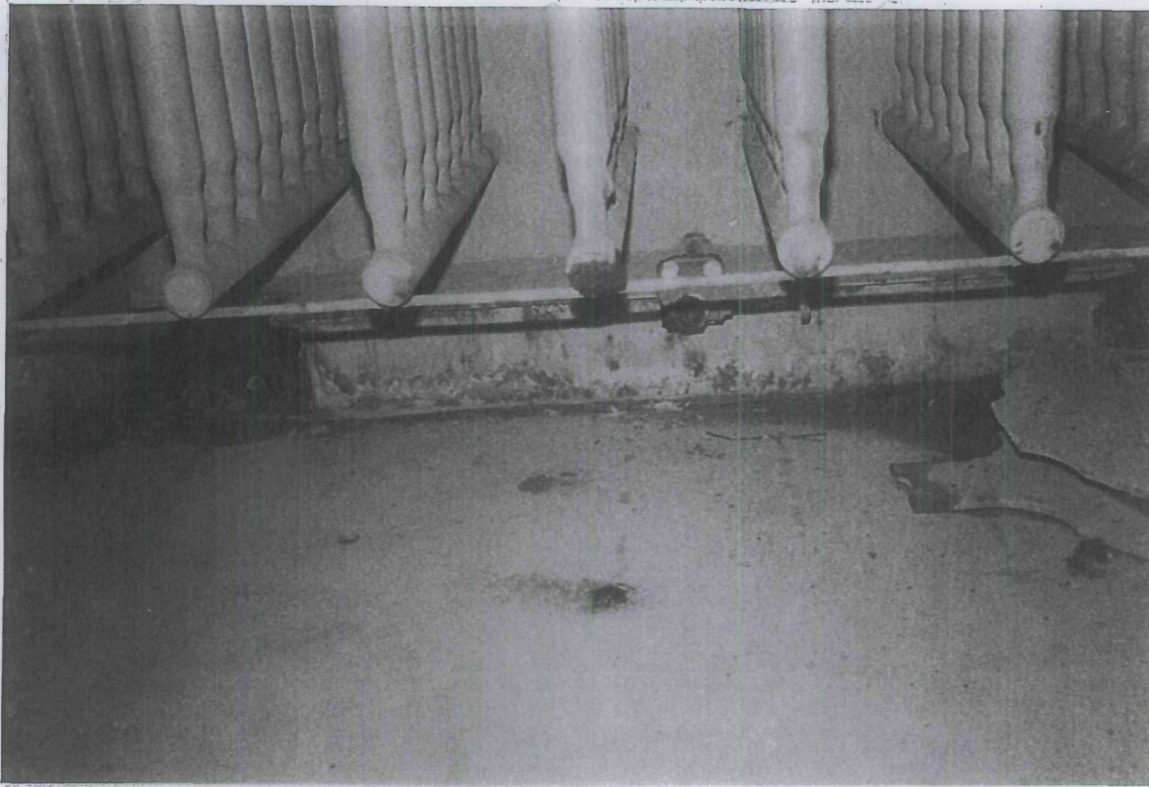
Sample JP-C-503736 was collected from one of the two transformers located in Room 1 on the first floor of Plant J-1. This grab sample was collected from hardened oil residue which appeared to be leaking from the base of a pipe and a valve on the transformer. The pipes to this transformer appeared to be rusted.

DESCRIPTION: Oil residue was also observed to be accumulated on the ends of one of the cooling pipes for transformer C-503736. A spot of oil residue was observed below this accumulation on the pipe.

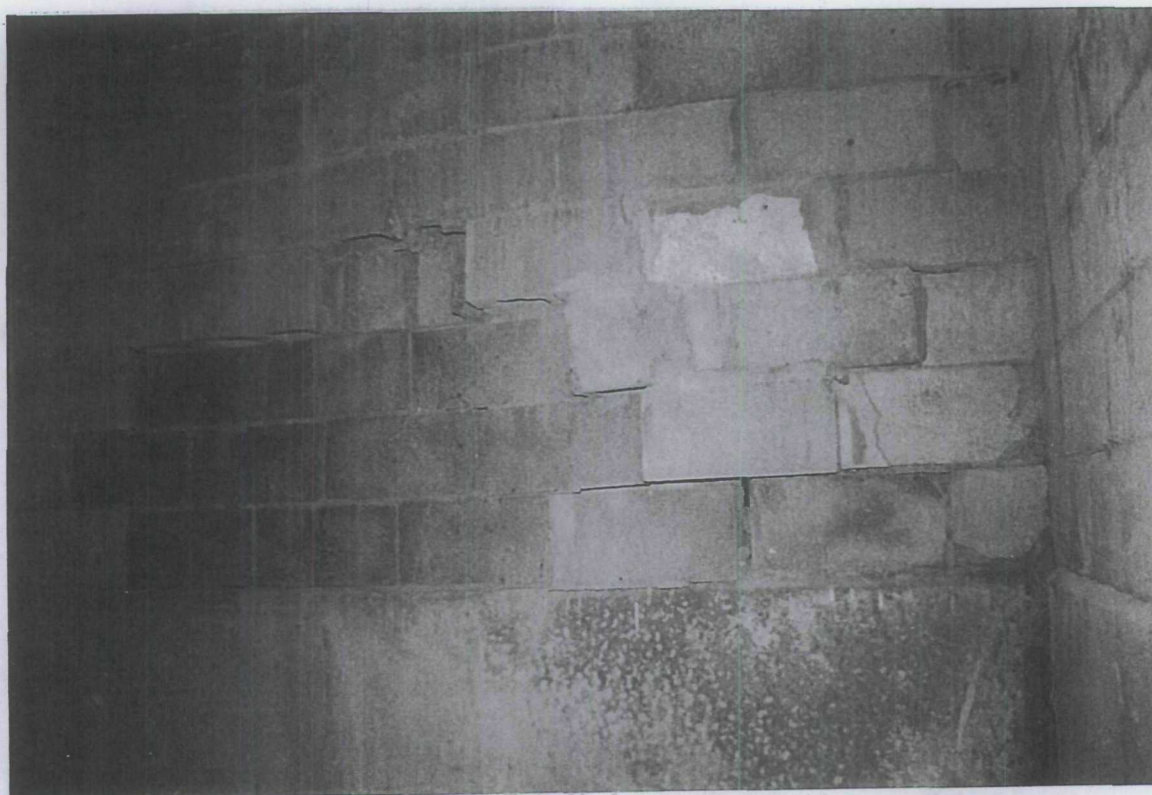
DESCRIPTION: The northwest wall of Room 1, Plant J-1, was observed to be of poor structural integrity. It also appears that previous attempts to repair the wall were conducted.

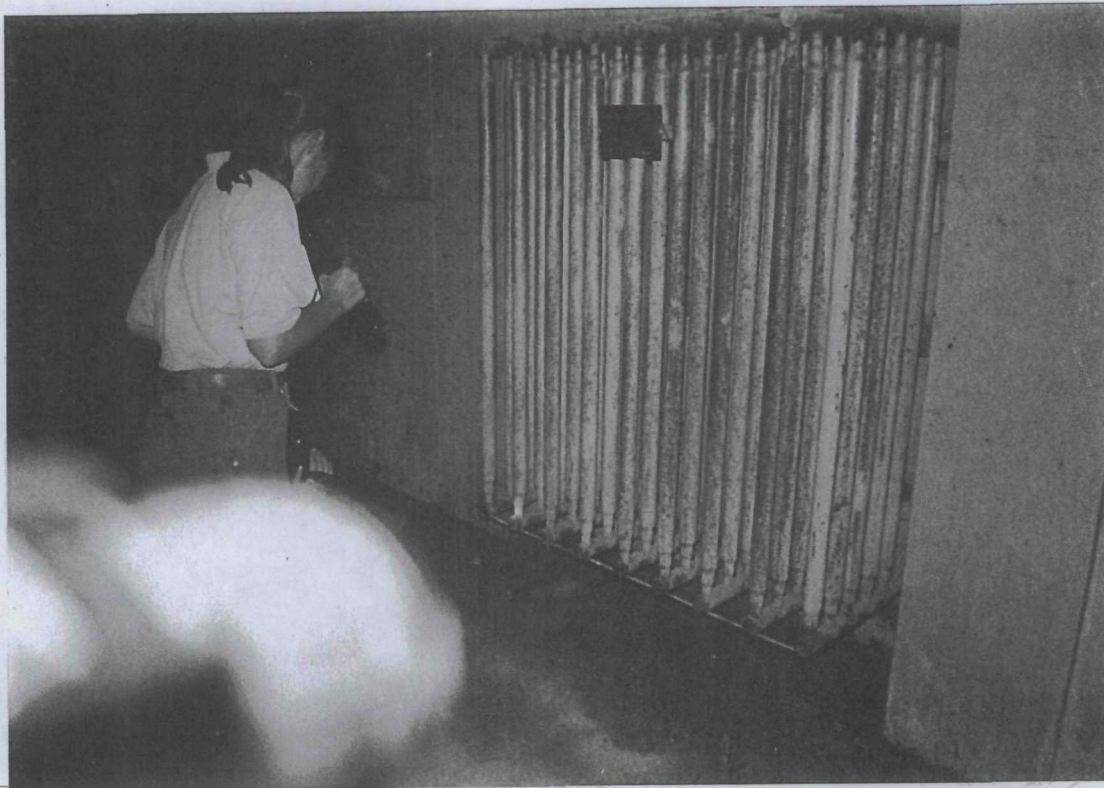
The cooling pipes on transformers C-503736, C-856081, and C-657612 were observed to be significantly corroded. Oil stains below plugs and valves on transformers C503736, C-657612, C-656340, C-856281, and L-249412 were visible. Transformers L-249412 and C-856281 exhibited the greatest amount of oil leakage on the flooring below their cooling pipes, valves, and plugs. Oil residue was observed around valves and plugs also. Transformers C-657612 and C-656340 exhibited oil stains on the soil/gravel surface below their cooling pipes. The outdoor substation where these transformers are located is fenced in; however, the gates to the fence are not secured with any locking mechanism.

DESCRIPTION: Transformer C-856081, located in Room 2, Plant J-1, was observed to be significantly rusted especially on the cooling pipes. The atmosphere in Room 2 was observed to be very damp.

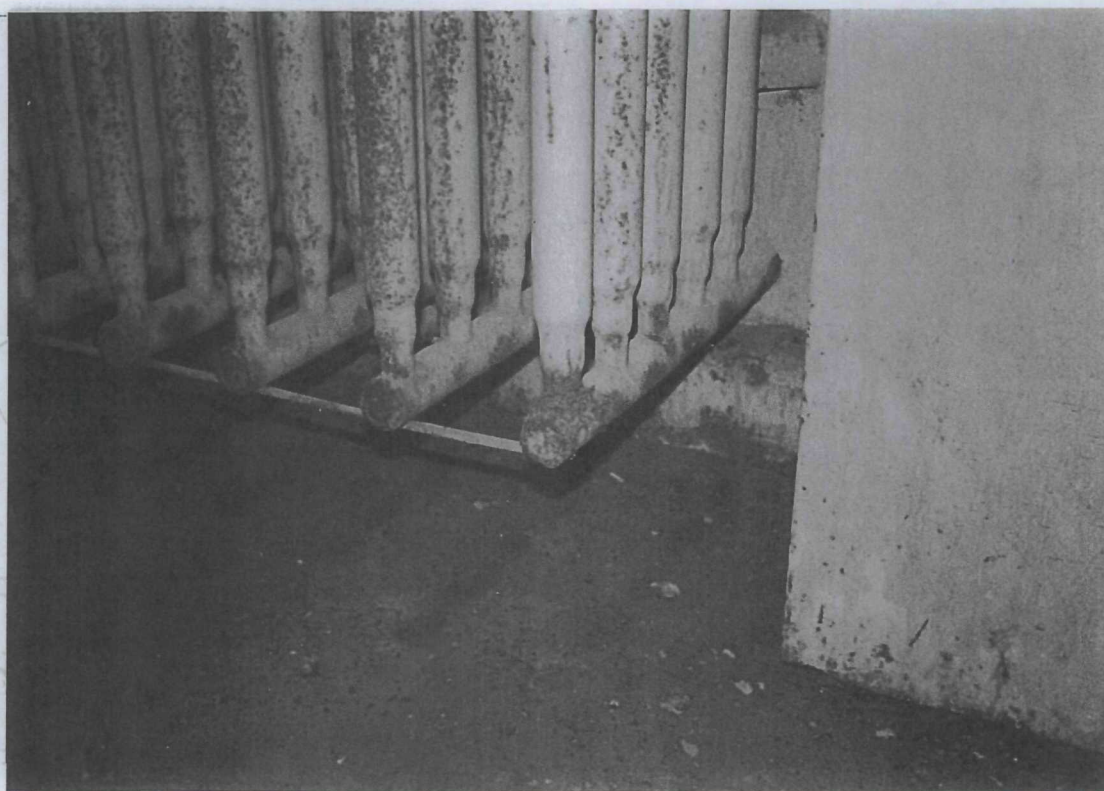
DESCRIPTION: This is a close-up view of the rusted cooling pipes on transformer C-856081.

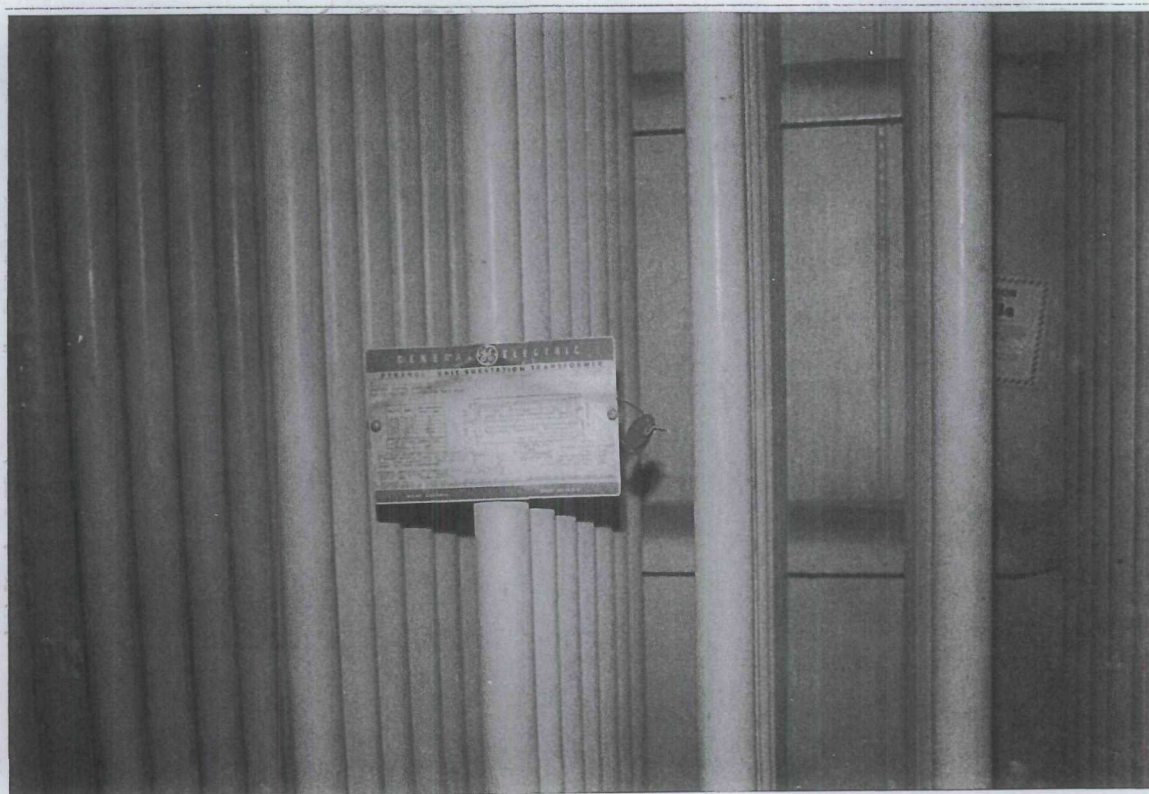
DESCRIPTION: A view of the metal ID plate on transformer C-503735. Notice the yellow PCB caution label located on the transformer case. A floor drain is located within five feet of this transformer. The transformer appears to be in good condition with minimal rusting evident.

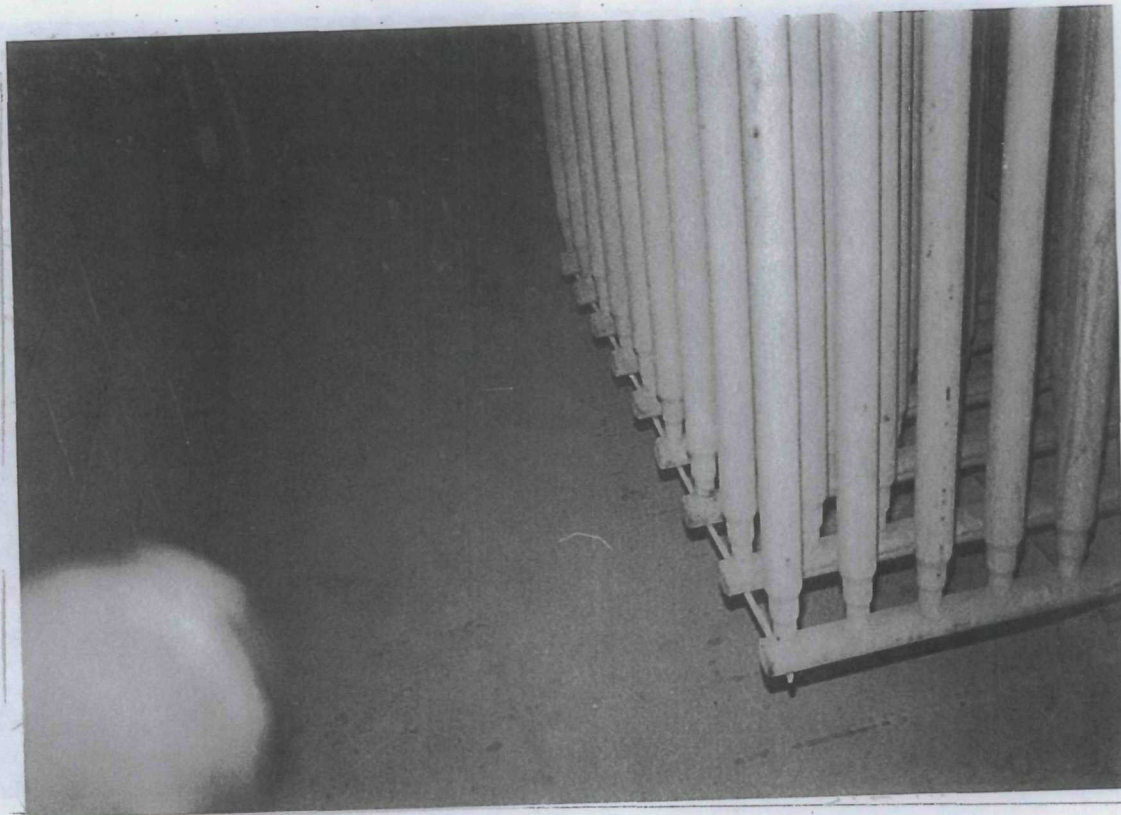
DESCRIPTION: This is a view of the rear side of transformer C-503735. Minimal rusting was evident.

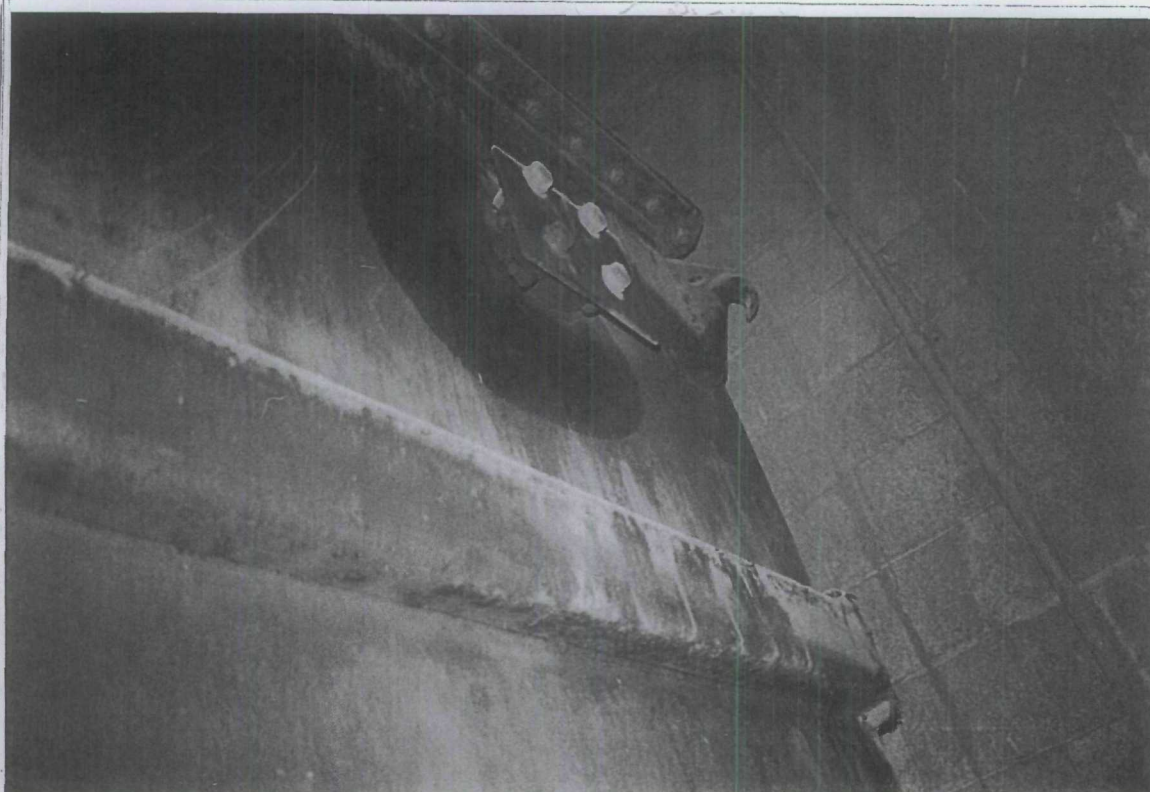
DESCRIPTION: A moisture/oil ring was observed around the circumference of an access port near the top of transformer C-657628 on one of its sides.

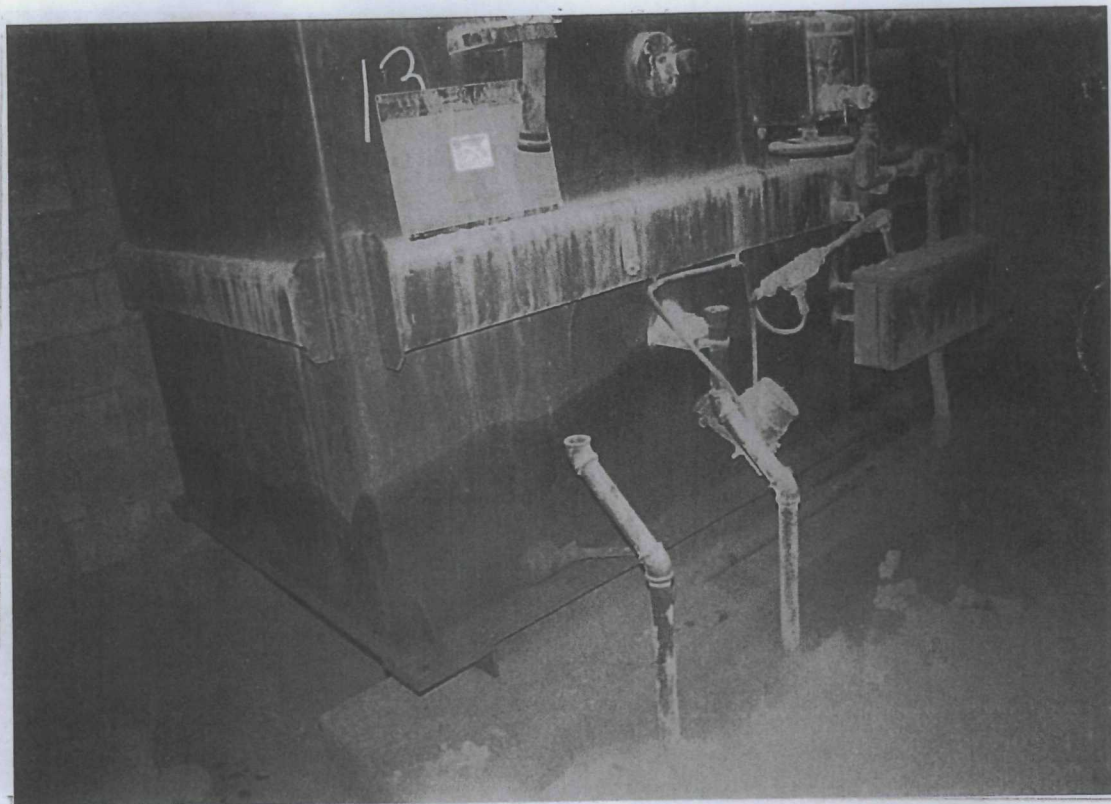
DESCRIPTION: A moisture/oil ring was observed around the base of transformer C-657628 on all four sides.

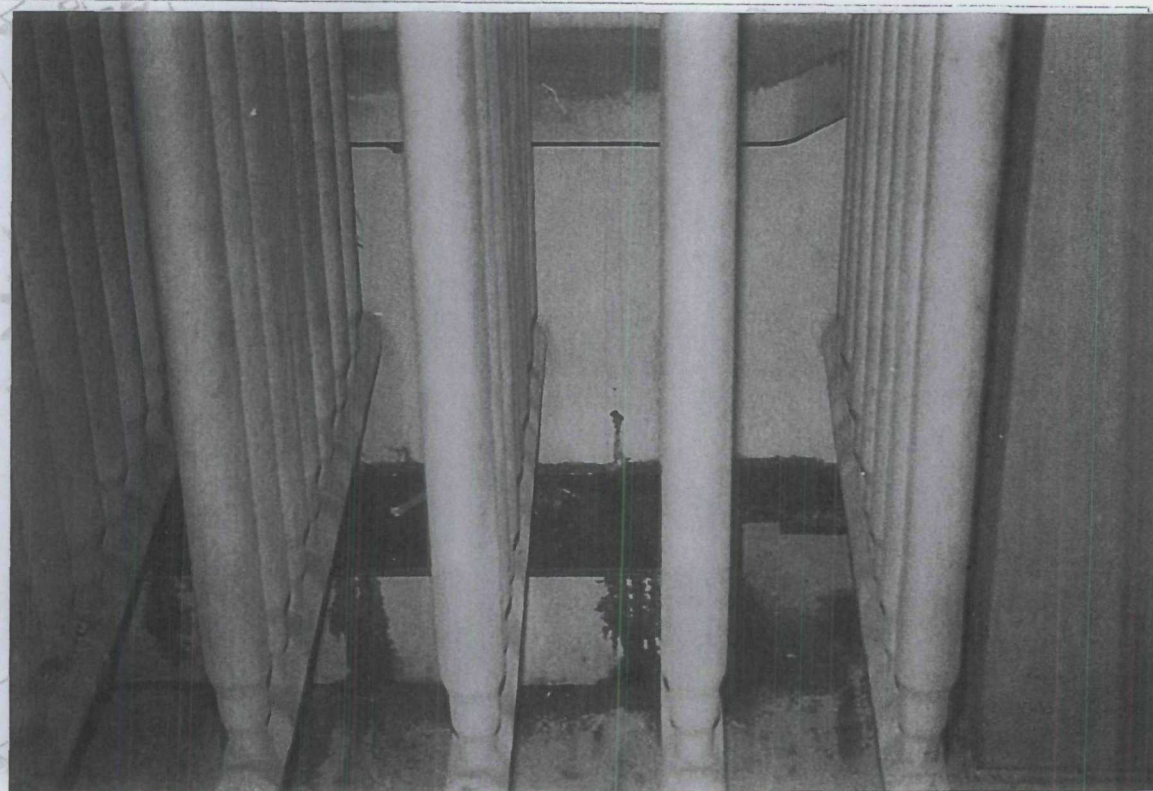
Room 1 on the fourth floor of Plant J-2 contained the General Electric Pyranol Unit Substation Transformer, serial number C-856281. Oily residue was observed on the floor and base of the transformer on its eastern side. A floor drain was located within 5 feet from the oil residue and the eastern side of the

DESCRIPTION: Oil residue was observed to have leaked from the base of transformer C-856281. A floor drain was within five feet of this oil residue.

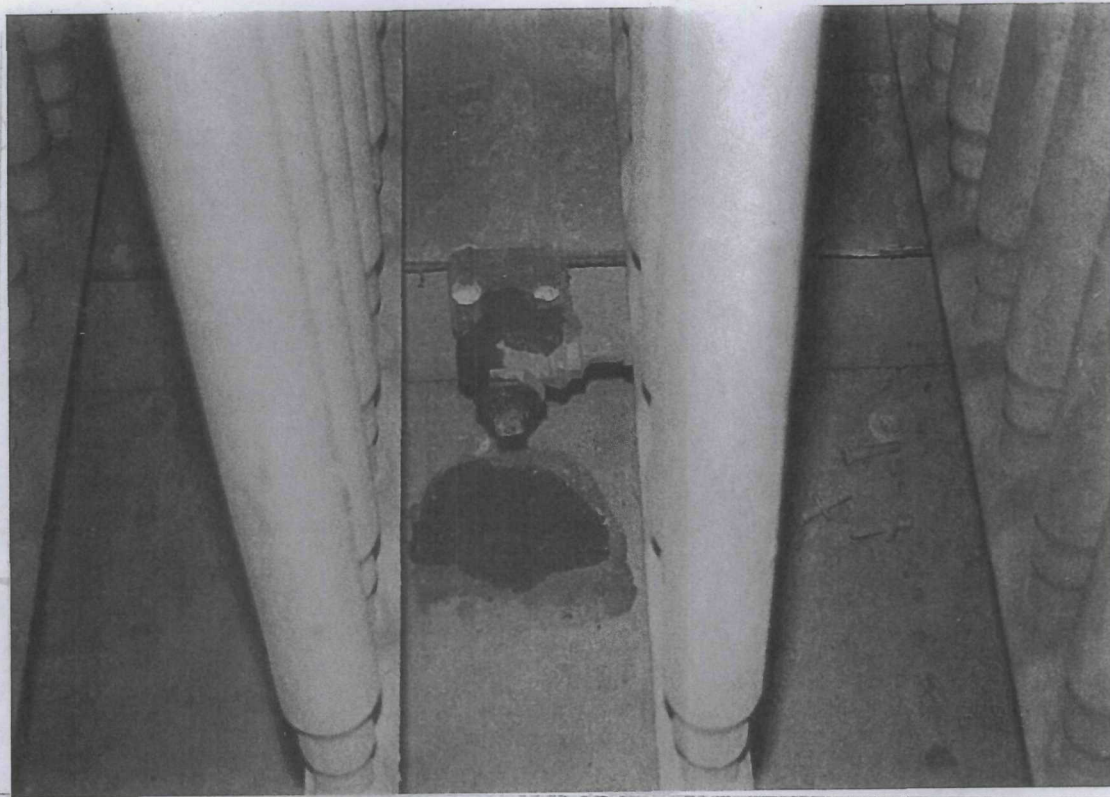
transformer. A valve on the west side of the transformer also appeared to be leaking and there was a visible oil spot on the floor below the valve. Room 2 on the fourth floor of Plant J-2 contained General Electric Transformer, serial number L-249412. The lower valve on this transformer appeared to be leaking oil onto the floor. START also observed a 1 to 2 inch layer of fine dust on the floor under the leaking valve which also had a considerable amount of oil residue in it. Room 3 on the third floor of Plant J-2 was not accessible due to the door being welded shut. The door was marked with a blue label indicating that the dielectric fluid in the unit contained less than 50 ppm PCB and was therefore classified as a non-PCB. According to the security personnel, a room is located on an upper level of Plant J-2 and believed to also contain a transformer. However, access to this room is not possible due to missing stairways to that upper level and the room is not accessible by any other level. This area will be referred to as Room 4 of Plant J-2.

DESCRIPTION: A plugged valve on the rear side of transformer C-856281 appeared to have oil residue accumulation around the plug. There was also an oil spot on the floor below the plugged valve.

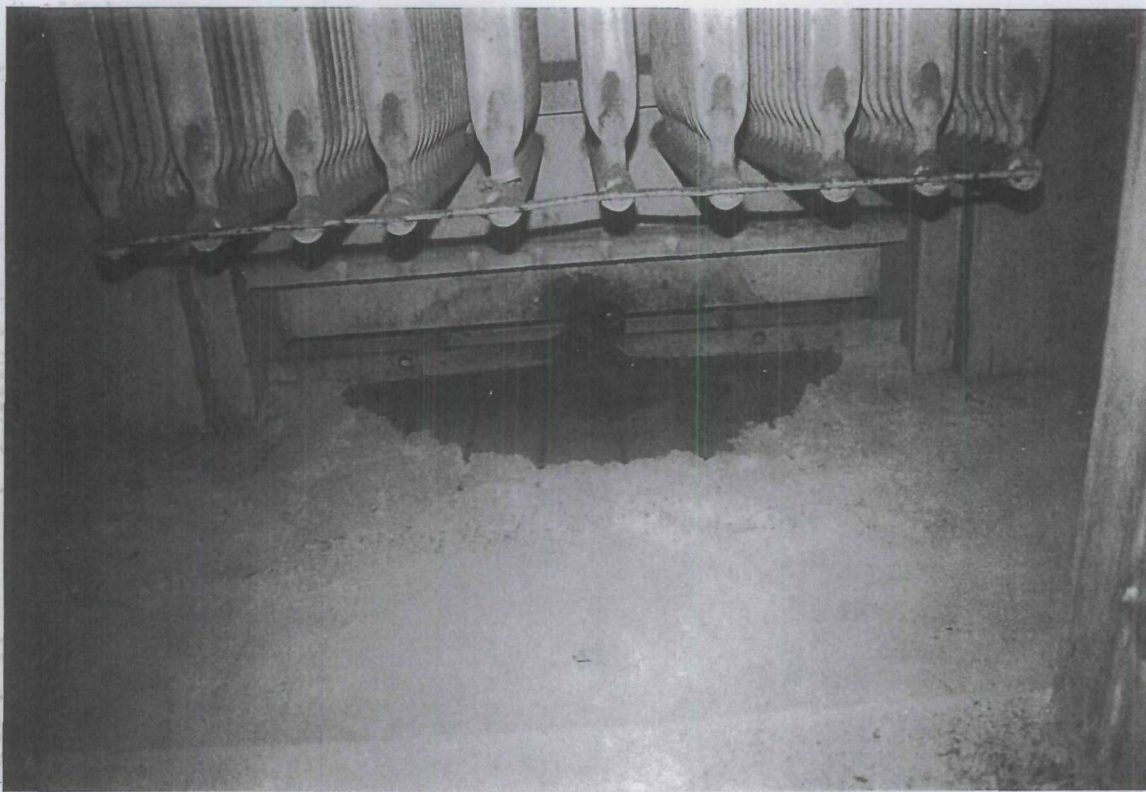
Sample JP-L-249412 was collected from Room 2 on the fourth floor of Plant J-2. This grab sample was collected from hardened oil residue around a valve on the transformer which appeared to be leaking and from hardened oil on the floor beneath the valve.

DESCRIPTION: Heavy oil residue was observed on the floor of Room 2, Plant J-2, below a valve on transformer L-249412. The valve was also observed to have a heavy accumulation of oil on it.

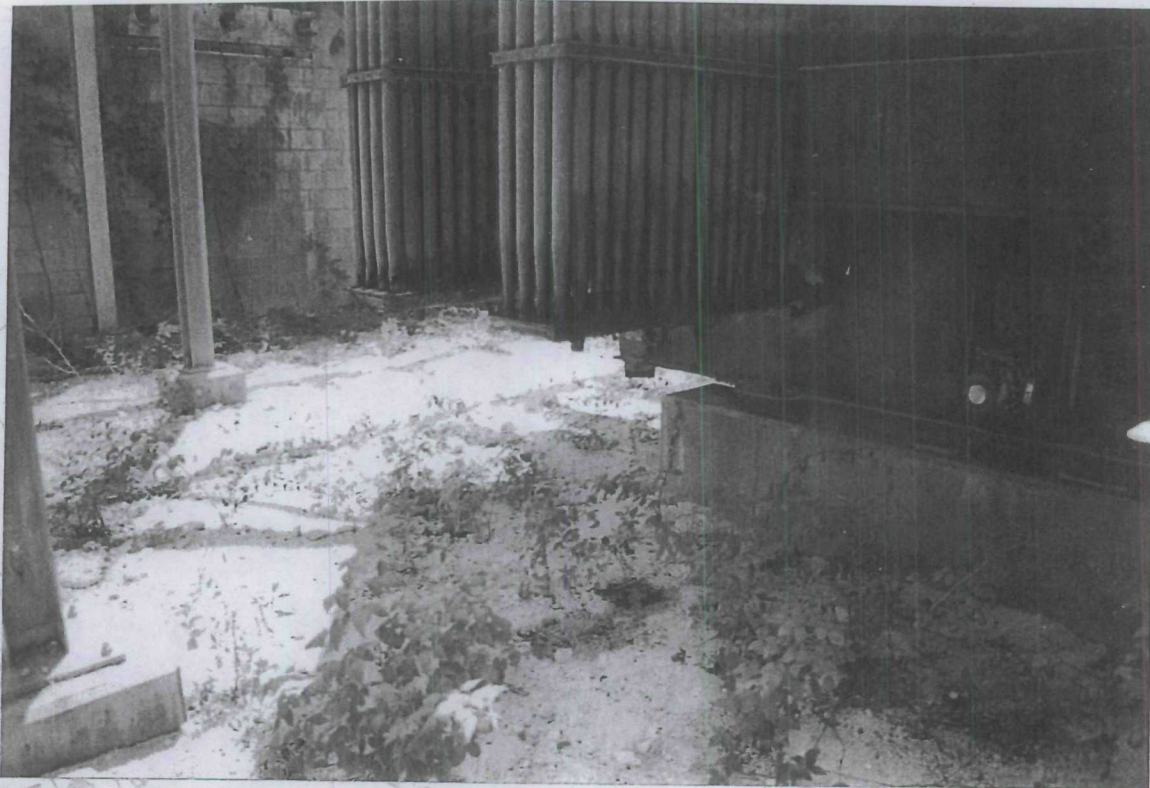
Sample JP-C-657612 was collected from the southwestern most transformer in the outdoor substation. The composite sample consisted of rust and residue found on the base of one section of cooling pipes and, rust stained soils which also appeared to have a slight oily discoloration. The soils were located below the rusted cooling pipes which were sampled for the composite. All samples were analyzed for total PCBs.

DESCRIPTION: The bottoms of the cooling pipes to transformer C-657612 were observed to be severely corroded. A stain which appeared to be from oil was observed on the ground surface below the corroded cooling pipes.

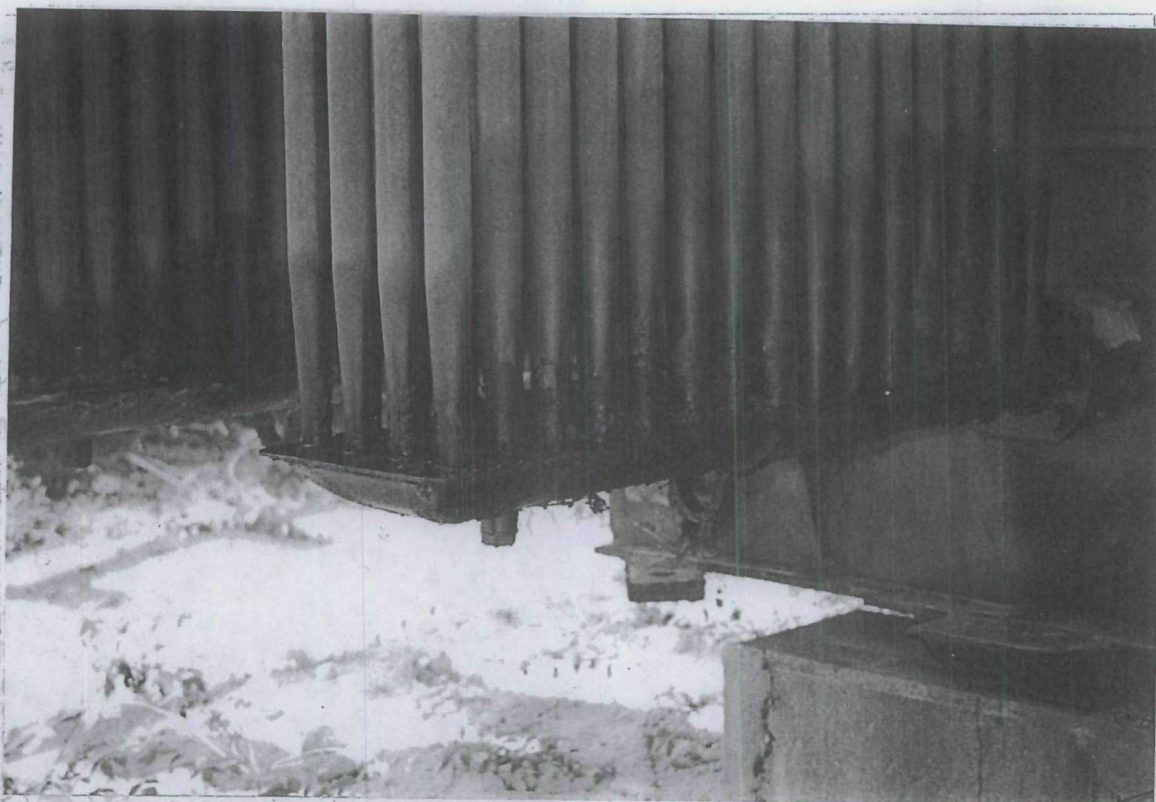
DESCRIPTION: A close-up view of the corroding cooling pipes on transformer C-657612.

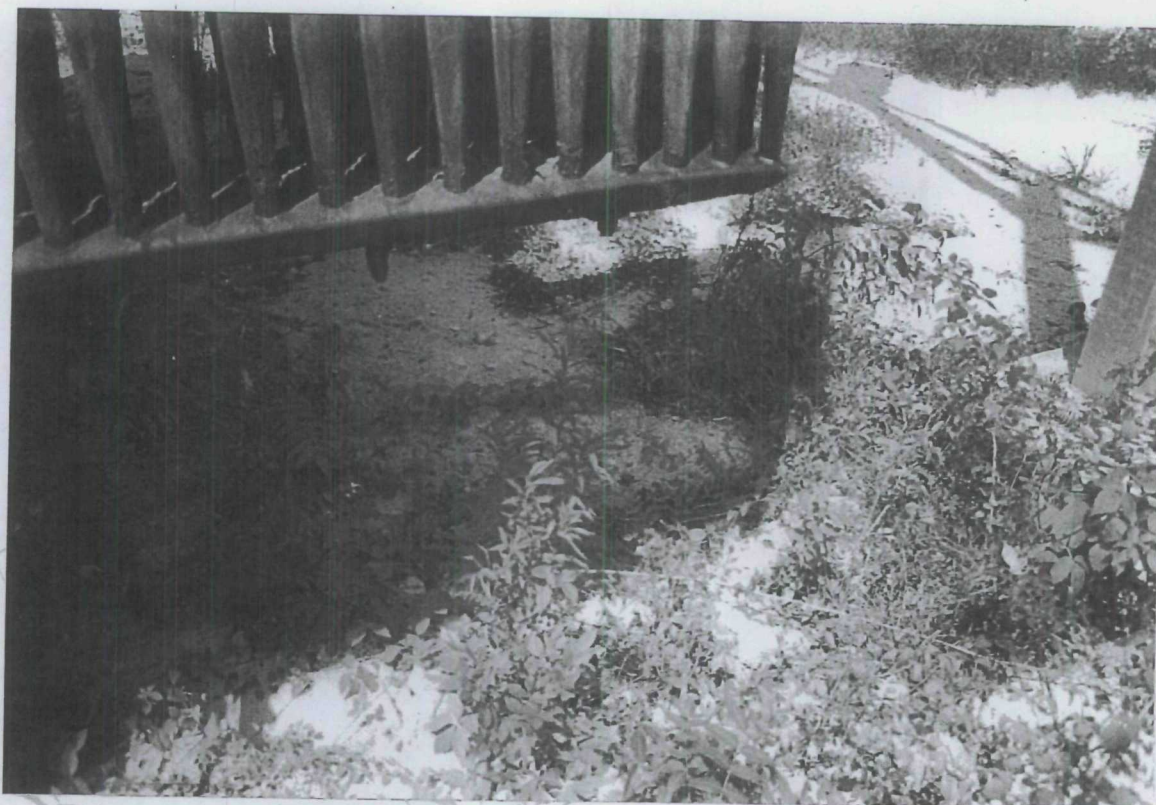
DESCRIPTION: The cooling pipes to transformer C-656340 were observed to be badly corroded. A wipe sample was collected from the plug located on the far right underside of the cooling pipe base. A black/gray discoloration of the soil below this plug was observed. The discoloration appeared to be an oil stain.

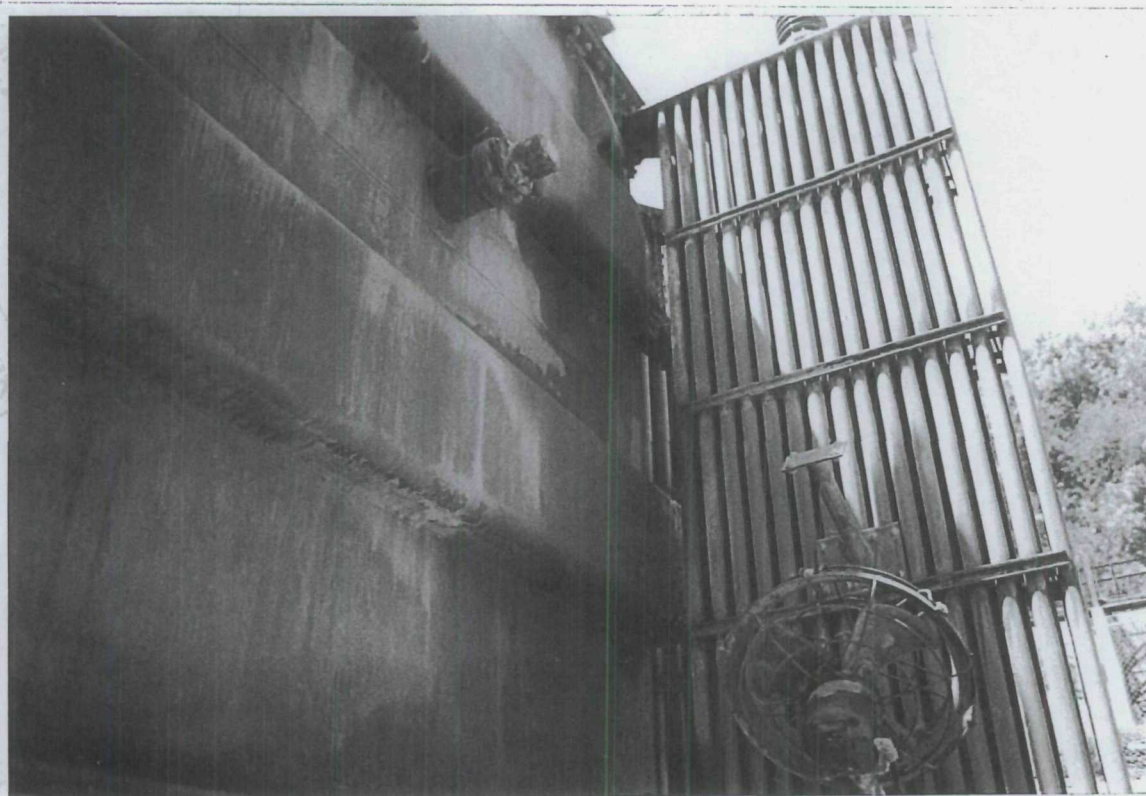
DESCRIPTION: Oil staining on the sides of transformer C-656340 was observed.

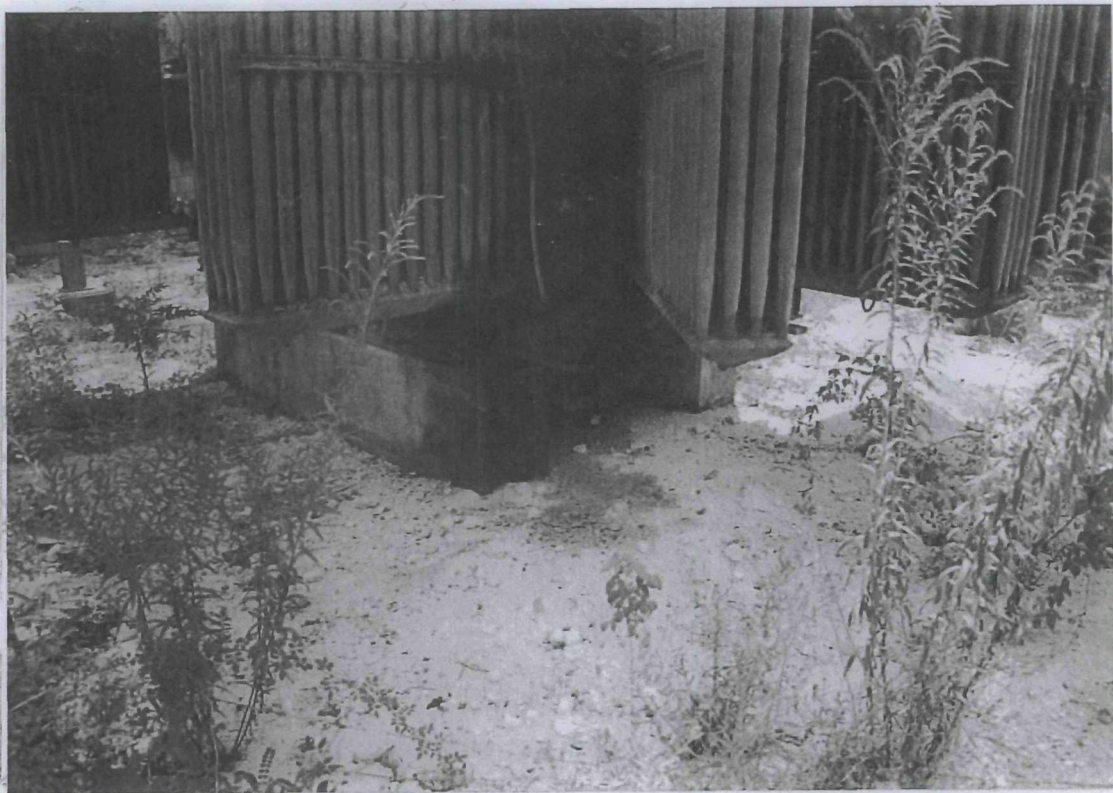
SITE: Jefferson Processing Site **TDD:** S05-9903-008 **PAN:** 9M0801SIXX **PHOTO:** 45
DIRECTION: Southeast **DATE:** 8/11/99 **PHOTOGRAPHER:** Mayer
DESCRIPTION: Oil staining was observed on the sides of transformer C-656340 and on the soil below the transformer.

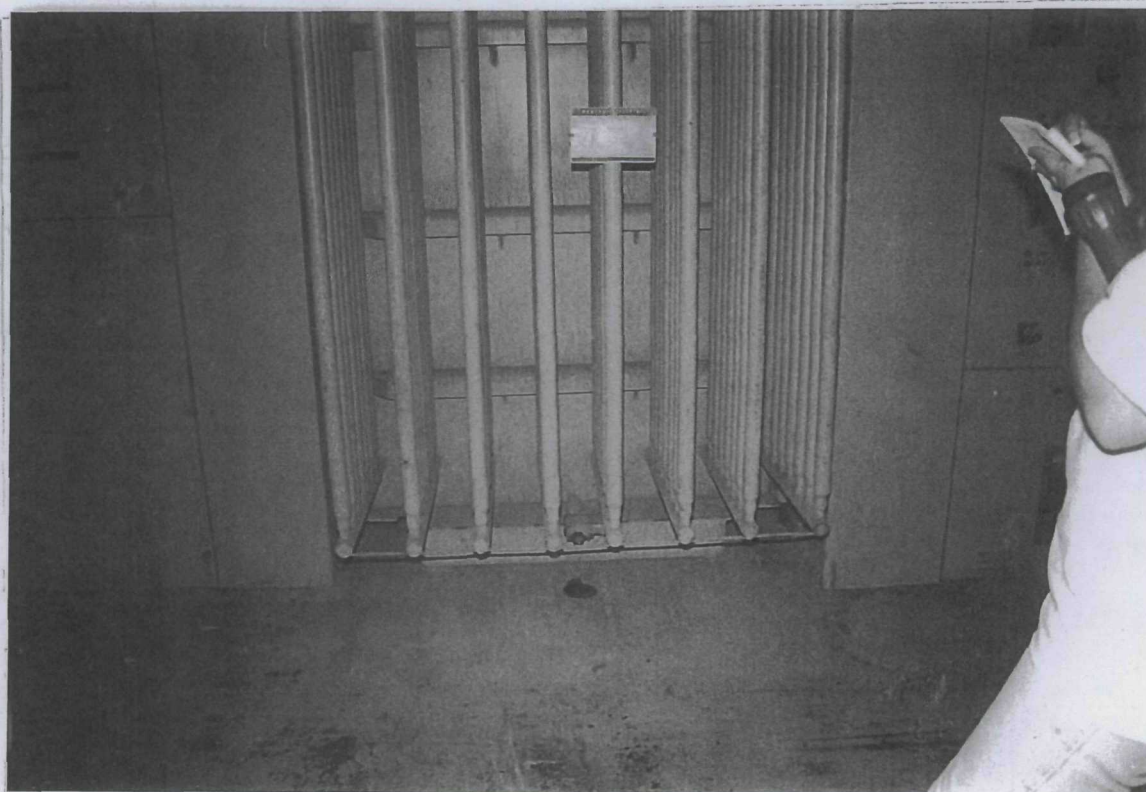
SITE: Jefferson Processing Site **TDD:** S05-9903-008 **PAN:** 9M0801SIXX **PHOTO:** 46
DIRECTION: Northeast **DATE:** 8/11/99 **PHOTOGRAPHER:** Bowerman
DESCRIPTION: Transformer C-856282 was located in the Pumphouse. A small oil drip stain was observed on the floor below a valve plug. However, the plug did not appear to be leaking currently.

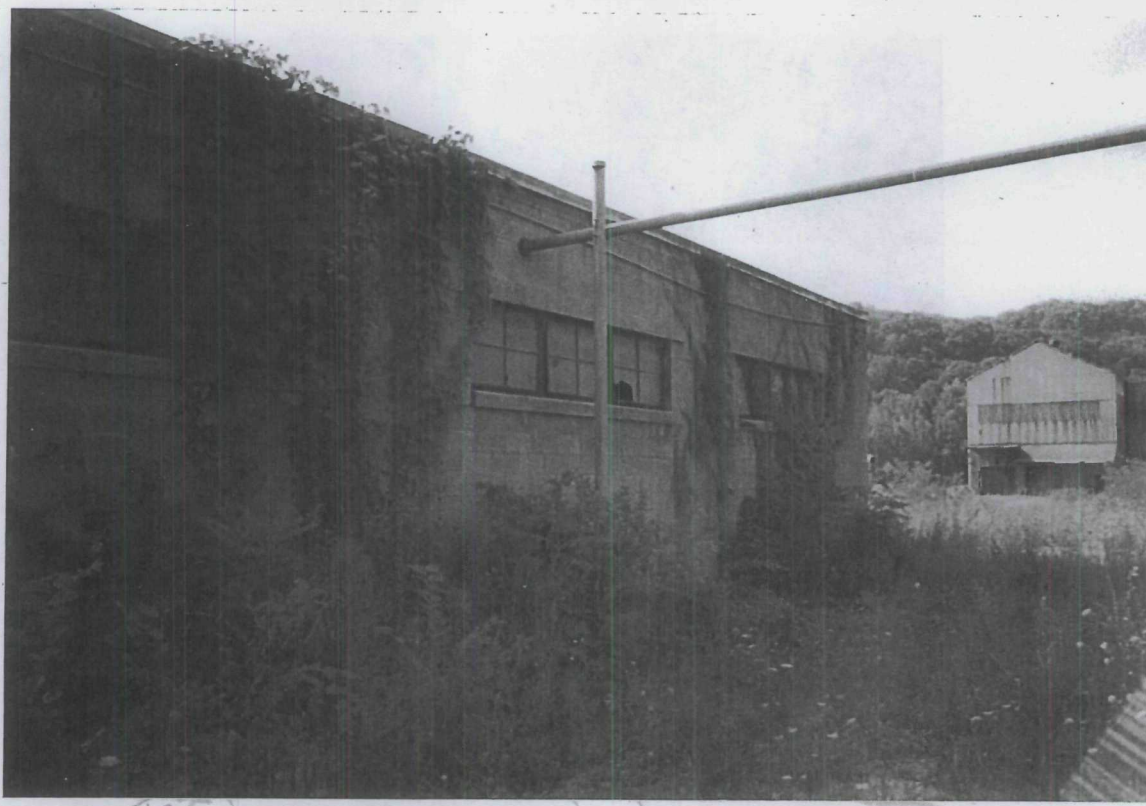
DESCRIPTION: In order to gain access into this building, an individual, using a ladder, reaches through the broken pane of glass on the northwest side of the Pumphouse, unhooks the lock, opens the window and climbs into the building. From the inside, the metal overhead bay door on the southeast side of the building is opened using the pulley chain. The window appeared to be locked.
